## Abbreviated Due Diligence Inspection

500 Chester Ave, Philadelphia  
Philadelphia, PA 19142

<b>Property ID</b>	500 Chester Ave, Philadelphia	<b>Inspection Date</b>	12/9/2025
<b>Template</b>	Abbreviated Due Diligence Inspection	<b>Property Floors</b>	2+ Floors
<b>Address</b>	500 Chester Ave, Philadelphia	<b>Main Floor bedrooms?</b>	1
<b>City, State, Zip</b>	Philadelphia, PA 19142	<b>2nd Floor bedrooms?</b>	3
<b>Property Type</b>		<b>Basement Present?</b>	Yes
<b>Inspector Name</b>	Blue Diamond Enterprises LLC	<b>Basement finished or unfinished?</b>	Unfinished

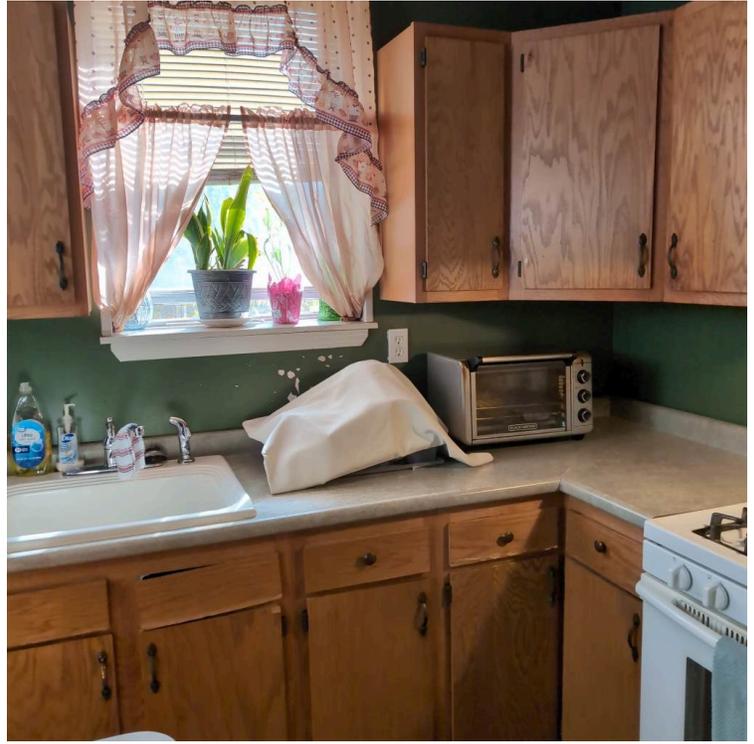
Kitchen / Walls/Outlets

<b>Walls/Outlets</b>	Not OK Need Gfci (2) per code
<b>Ceiling/Light</b>	Not OK bubbling paint in ceiling
<b>Cabinets/Tile</b>	Not OK Cabinets need light repair, flooring is sagging and missing
<b>Counter Top Type</b>	Formica
<b>Range/Microwave</b>	OK No microwave

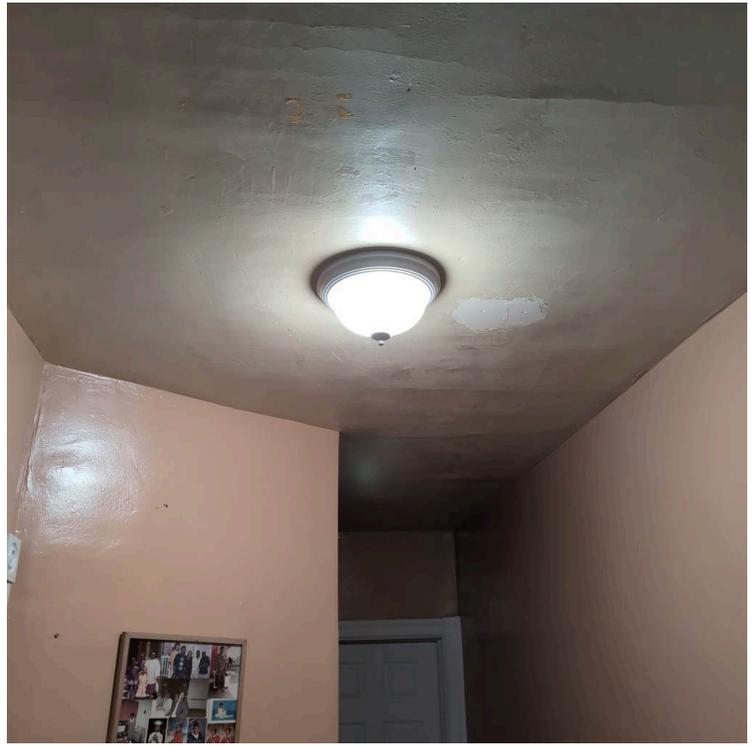
Bedroom Area / Ceiling/Light

<b>Number of Bedrooms</b>	3
<b>Walls/Outlets</b>	OK Walls are all cracking or have holes in them.
<b>Ceiling/Light</b>	Not OK Lights are missing covers, ceilings are deteriorating.
<b>Floor/Carpet</b>	Not OK Mixture of carpet and vinyl. Carpets should be replaced

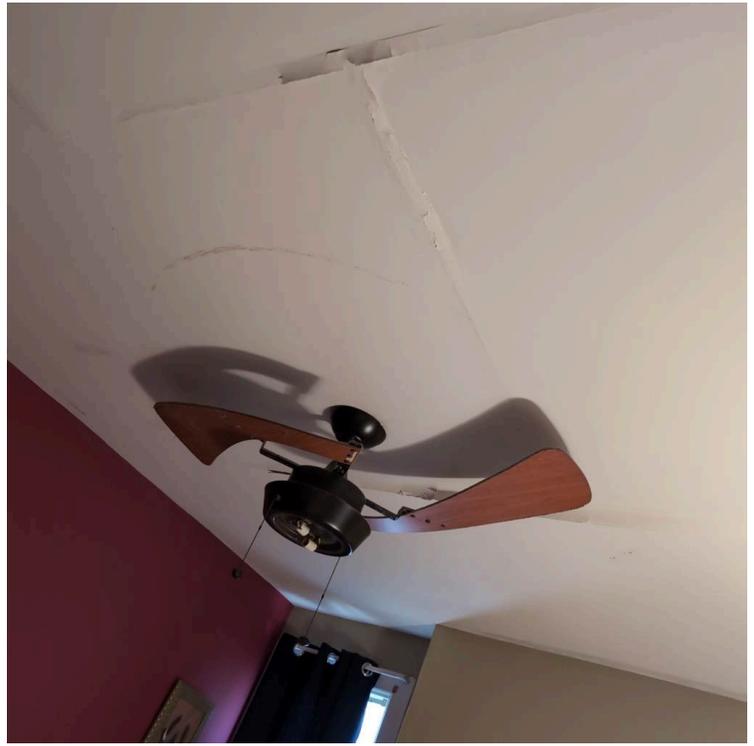
Bedroom Area / Bedroom Other

<b>Window/Blinds</b>	Not OK Access blocked by belongings
<b>Doors/Closets</b>	OK Doors are in good condition. Access to closets blocked.
<b>Bedroom Other</b>	Not OK Ceilings and walls need repair and paint.

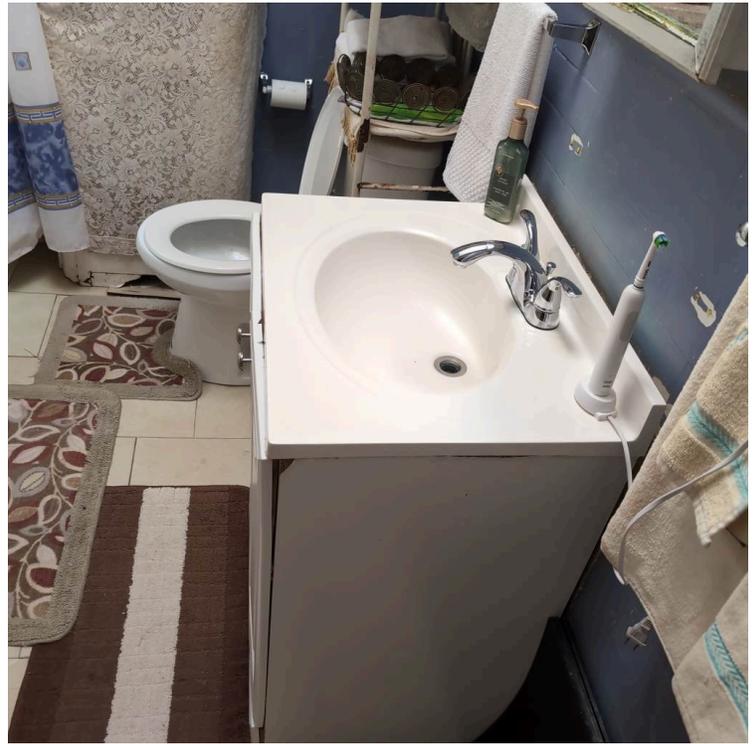
Bathroom Area / Counter Top Type

<b>Counter Top Type</b>	Other Vanity is off the wall.
<b>Fixtures</b>	Not OK

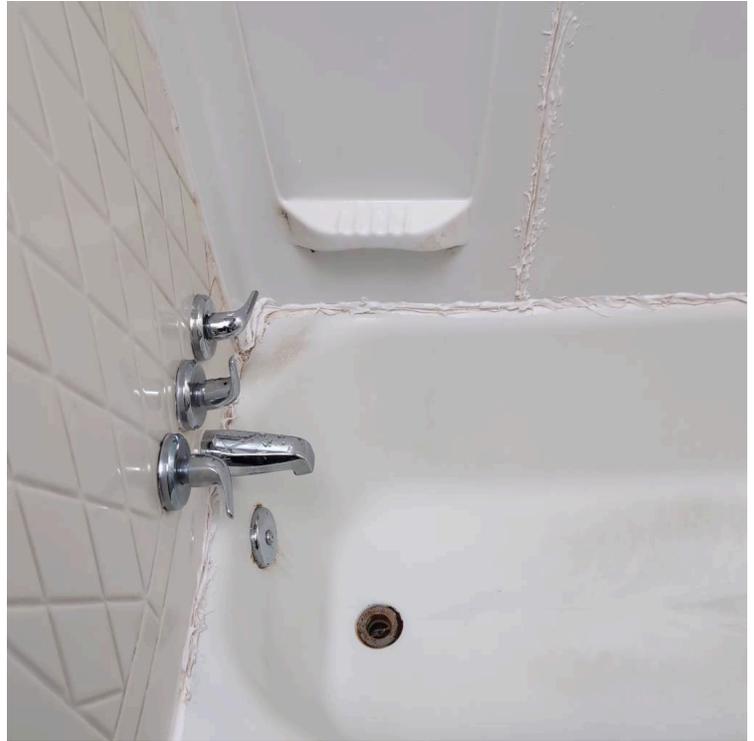
**Bathroom Area / Tub Enclosures**

<b>Tub Enclosures</b>	Not OK Vinty installed on existing vinyl, visible discoloration on ceiling.
<b>Bathroom Other</b>

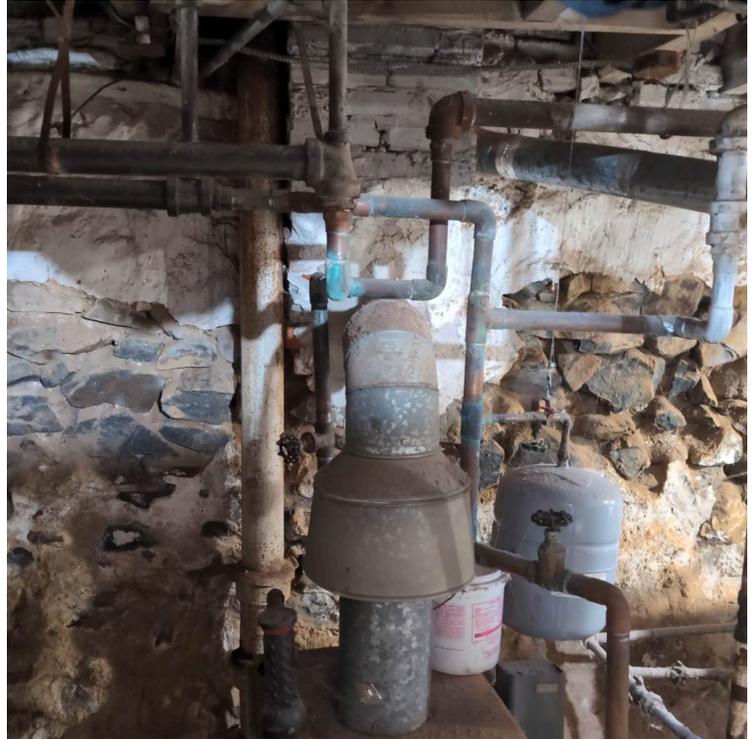
Mechanical / Plumbing - Evidence of Polybutylene, Galvanized Steel, or Lead Piping installed?

<b>Plumbing - Evidence of Polybutylene, Galvanized Steel, or Lead Piping installed?</b>	Yes Steel piping to boiler system
<b>Electrical System</b>	Not OK Hanging Wires, panel not up to code
<b>Washer &amp; Dryer Hookup Present?</b>	Yes Need water box for washer hookup
<b>Dryer Hookup Type?</b>	Electric Outlets need to be secured properly

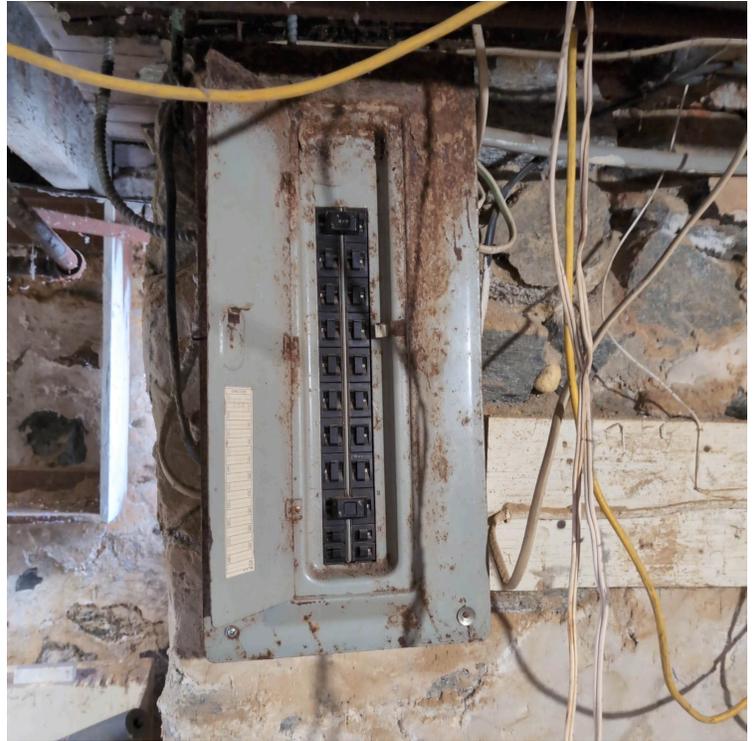
**Mechanical / Electrical Panel Photos**

Property is in fair condition. Repairs are needed throughout. Special attention should be paid to the kitchen flooring, lights throughout and basement walls. Electrical panel needs to be upgraded as it is rusty and not up to code. No roof access. No rear year access due to broken rear door.
