## Abbreviated Due Diligence Inspection

500 Chester Ave, Philadelphia  
Philadelphia, PA 19142

<b>Property ID</b>	500 Chester Ave, Philadelphia	<b>Inspection Date</b>	12/9/2025
<b>Template</b>	Abbreviated Due Diligence Inspection	<b>Property Floors</b>	2+ Floors
<b>Address</b>	500 Chester Ave, Philadelphia	<b>Main Floor bedrooms?</b>	1
<b>City, State, Zip</b>	Philadelphia, PA 19142	<b>2nd Floor bedrooms?</b>	3
<b>Property Type</b>		<b>Basement Present?</b>	Yes
<b>Inspector Name</b>	Blue Diamond Enterprises LLC	<b>Basement finished or unfinished?</b>	Unfinished

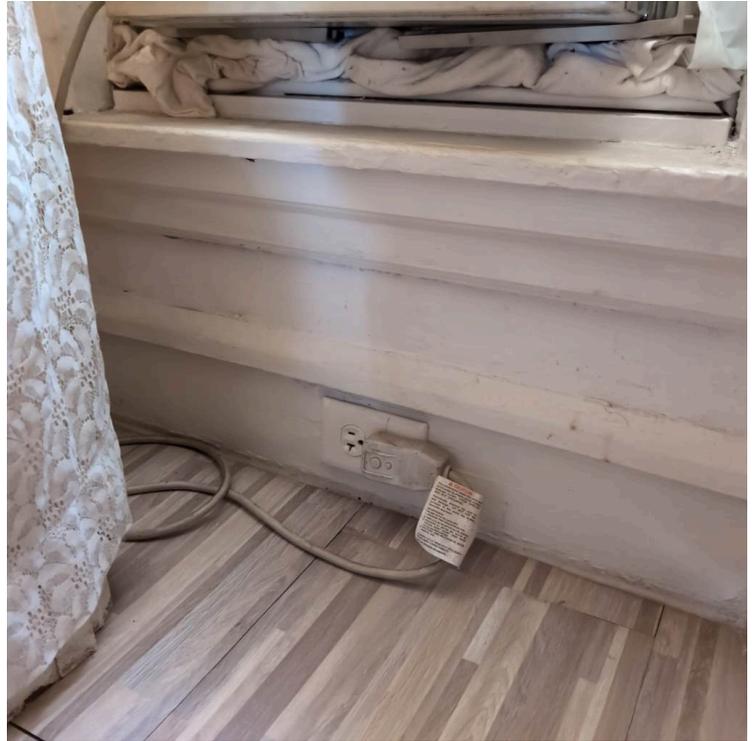
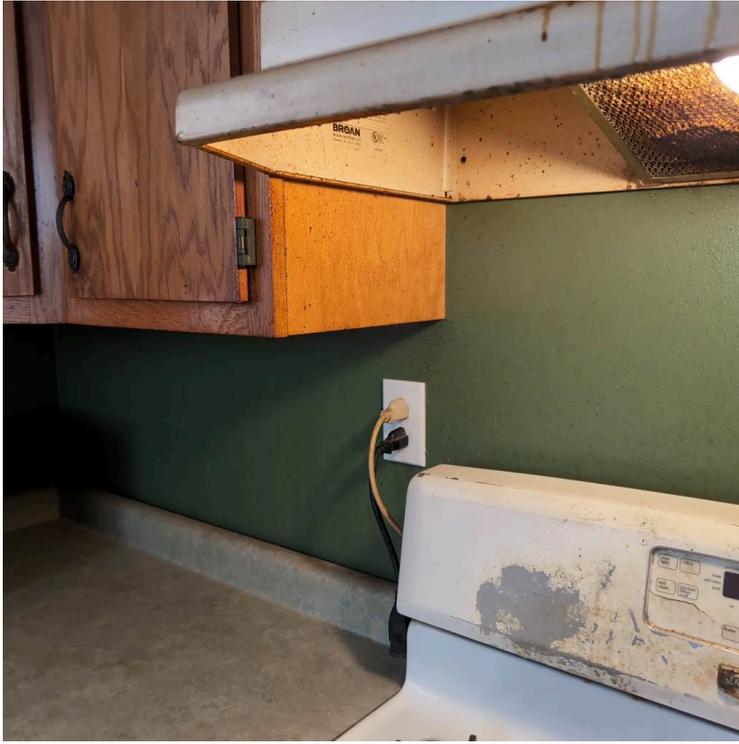
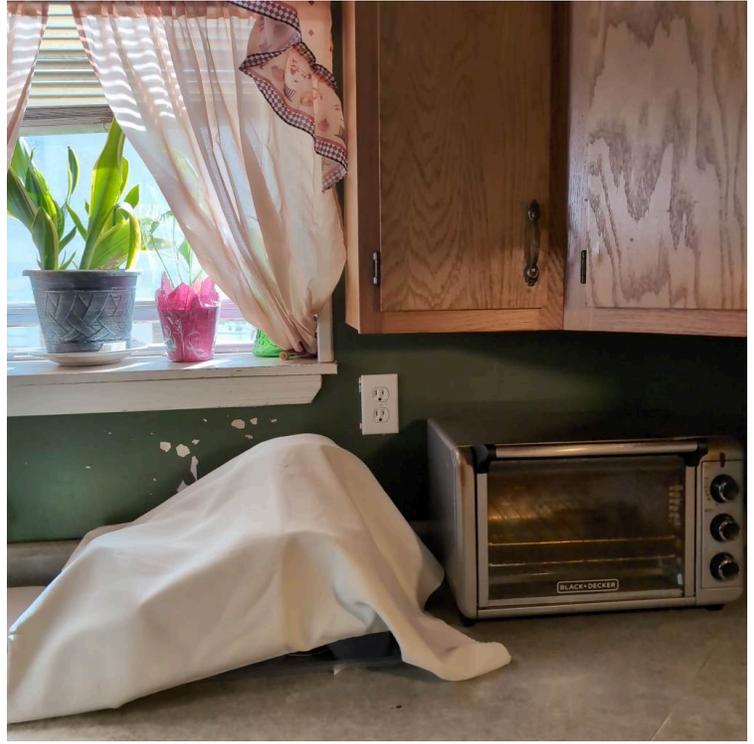
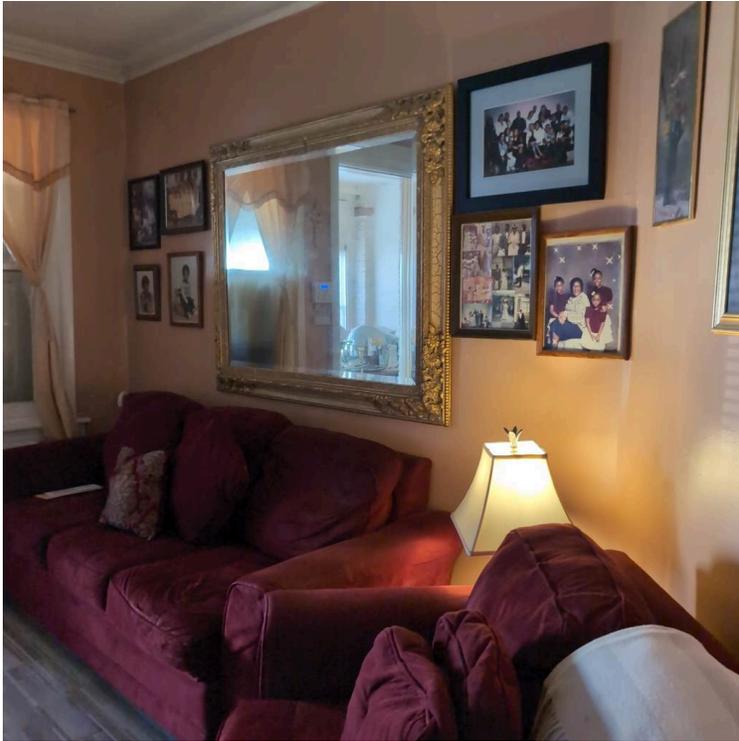
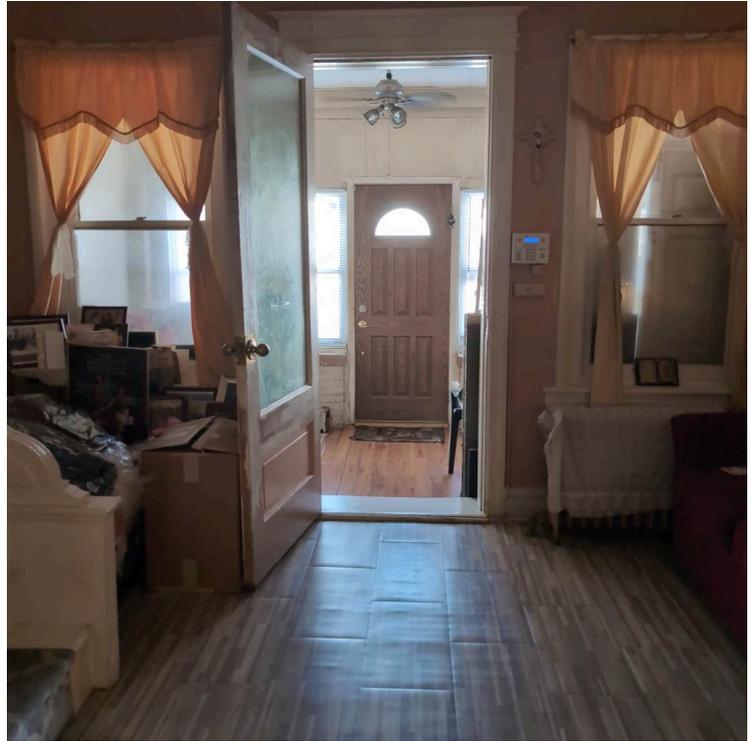
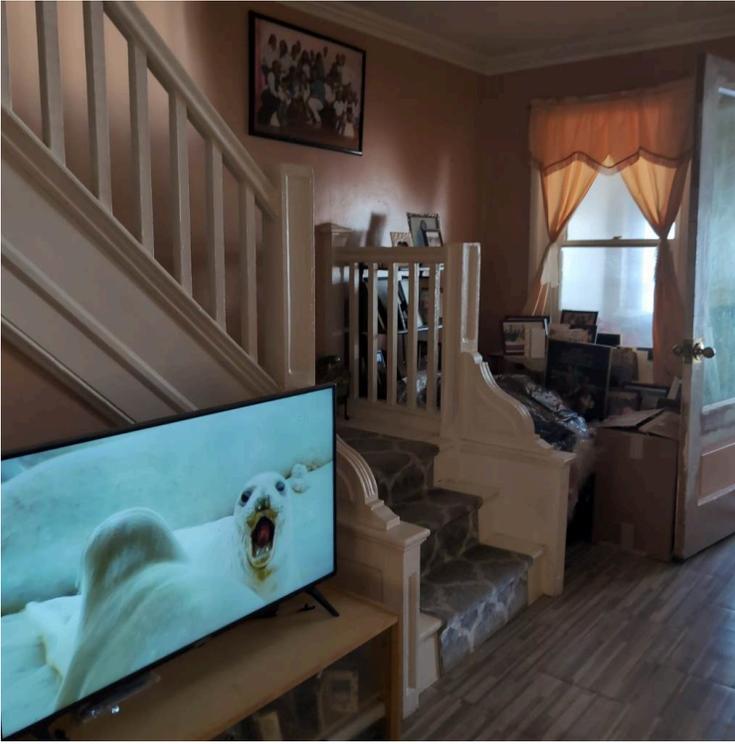
<b>Walls/Outlets</b>	OK need gfci in kitchen(2)
<b>Ceiling/Light</b>	OK Ceiling lights are old but in good working condition
<b>Floor/Carpet</b>	Not OK Flooring is vinyl, in good shape except for the kitchen
<b>Window</b>	OK Windows are vinyl and metal, in good working condition.

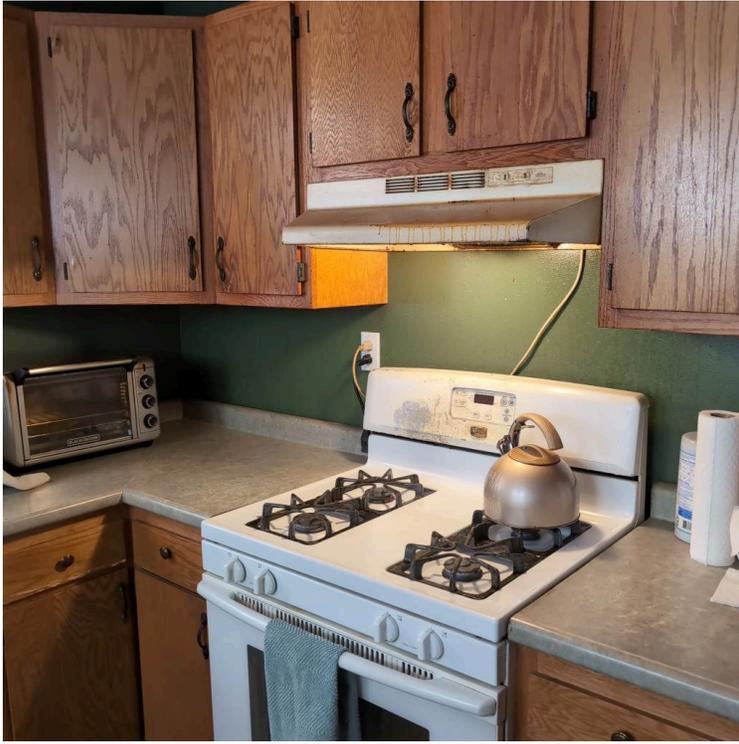
Kitchen / Walls/Outlets

<b>Walls/Outlets</b>	Not OK Need Gfci (2) per code
<b>Ceiling/Light</b>	Not OK bubbling paint in ceiling
<b>Cabinets/Tile</b>	Not OK Cabinets need light repair, flooring is sagging and missing
<b>Counter Top Type</b>	Formica
<b>Range/Microwave</b>	OK No microwave

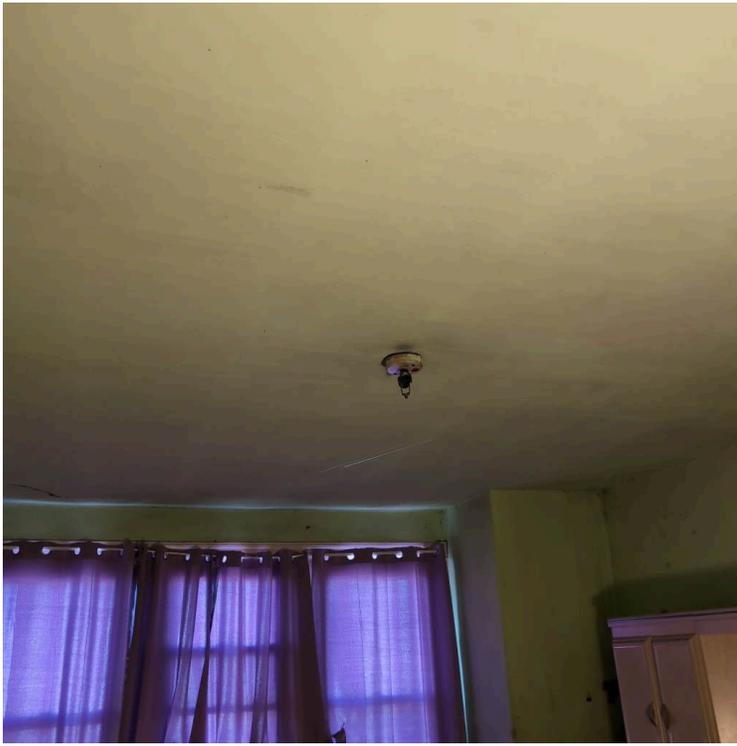
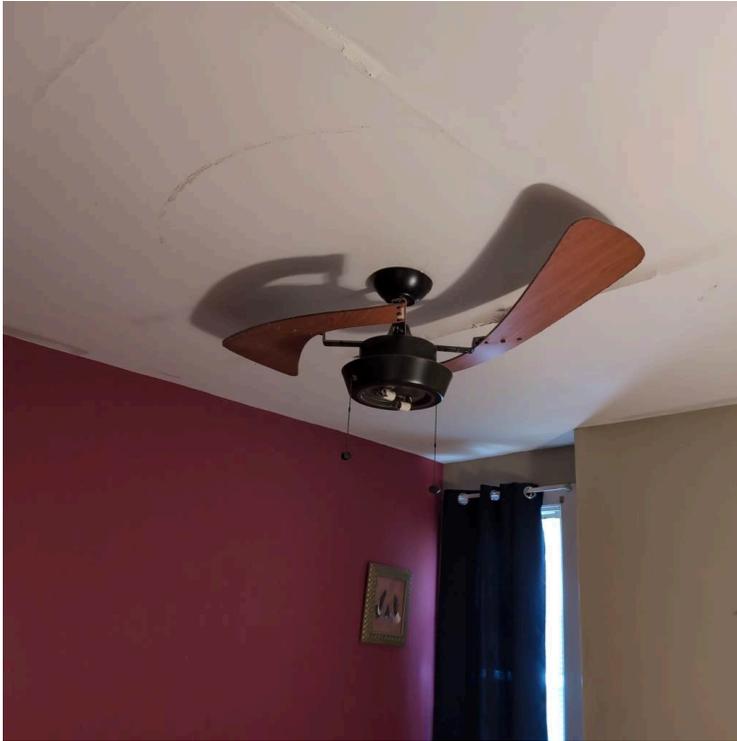
Bedroom Area / Ceiling/Light

<b>Number of Bedrooms</b>	3
<b>Walls/Outlets</b>	OK Walls are all cracking or have holes in them.
<b>Ceiling/Light</b>	Not OK Lights are missing covers, ceilings are deteriorating.
<b>Floor/Carpet</b>	Not OK Mixture of carpet and vinyl. Carpets should be replaced

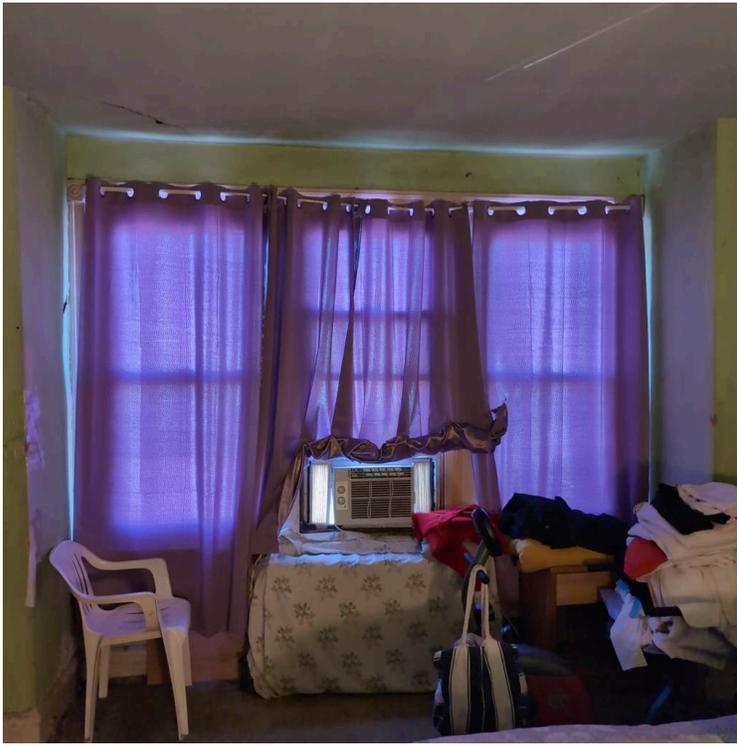
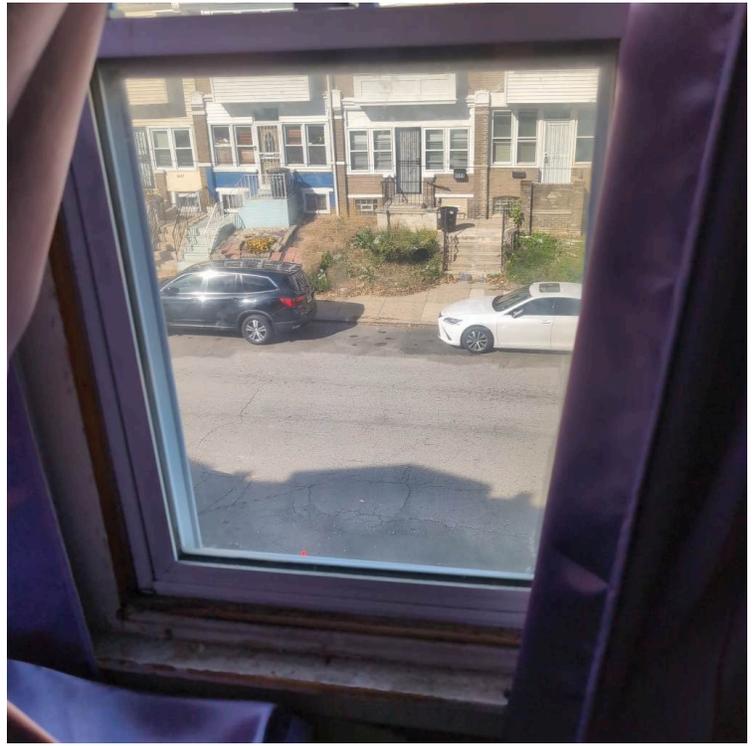
Bedroom Area / Window/Blinds

<b>Window/Blinds</b>	Not OK Access blocked by belongings
<b>Doors/Closets</b>	OK Doors are in good condition. Access to closets blocked.
<b>Bedroom Other</b>	Not OK Ceilings and walls need repair and paint.

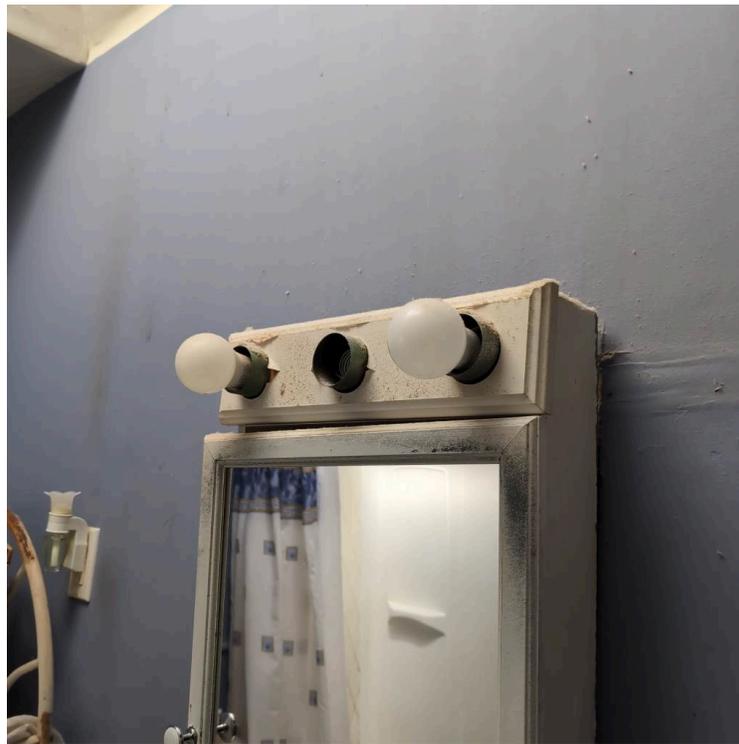
**Bathroom Area / Ceiling/Light**

<b>Ceiling/Light</b>	Not OK Only vanity light exists. Missing bulbs
<b>Floor</b>	Not OK Separating and missing tiles
<b>Cabinets/Mirror</b>	Not OK Worn cabinet, separating from wall

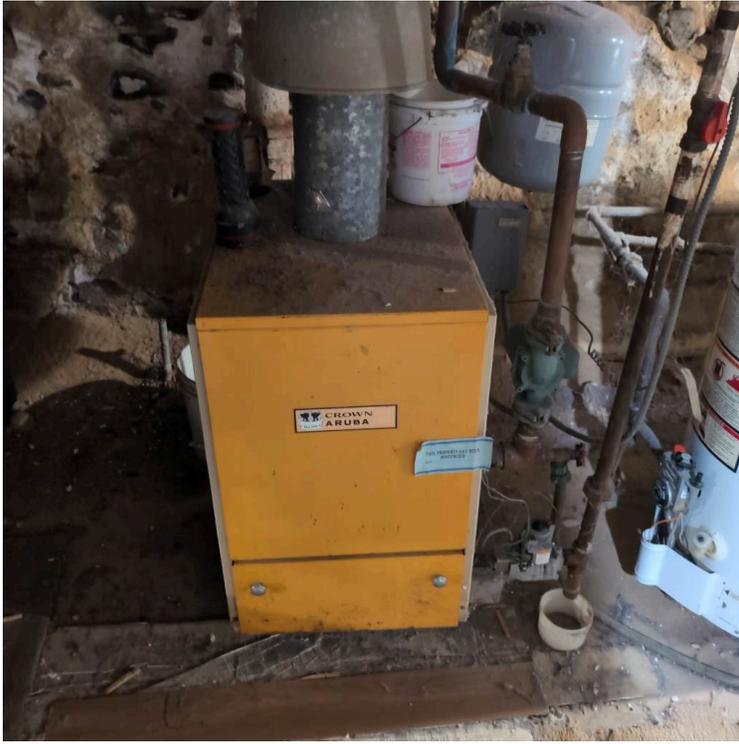
Mechanical / HVAC System

<b>HVAC System</b>	OK No HVAC, only boiler system to radiator heat
<b>HVAC Age</b>	Unknown
<b>Water Heater</b>	OK Older water heater, in fair condition
<b>Water Heater Age</b>	14 years
<b>Plumbing System</b>	Not OK Fair condition

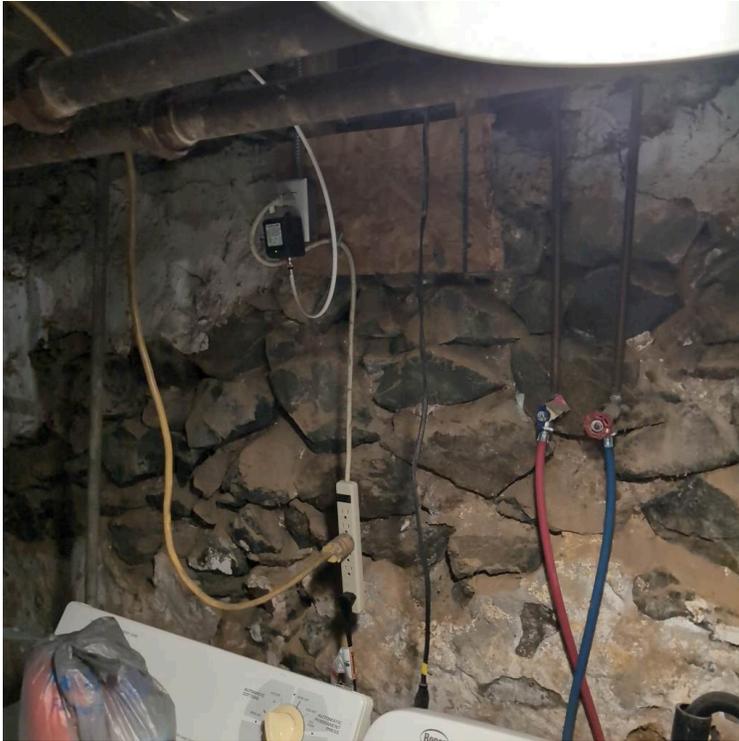
**Mechanical / Electrical System**

Property is in fair condition. Repairs are needed throughout. Special attention should be paid to the kitchen flooring, lights throughout and basement walls. Electrical panel needs to be upgraded as it is rusty and not up to code. No roof access. No rear year access due to broken rear door.
